Supporting Information

Cao et al. 10.1073/pnas.0900197106

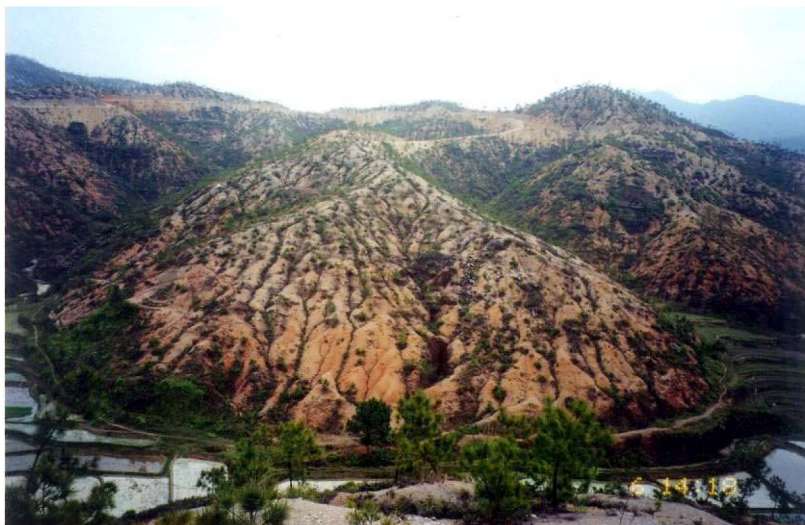
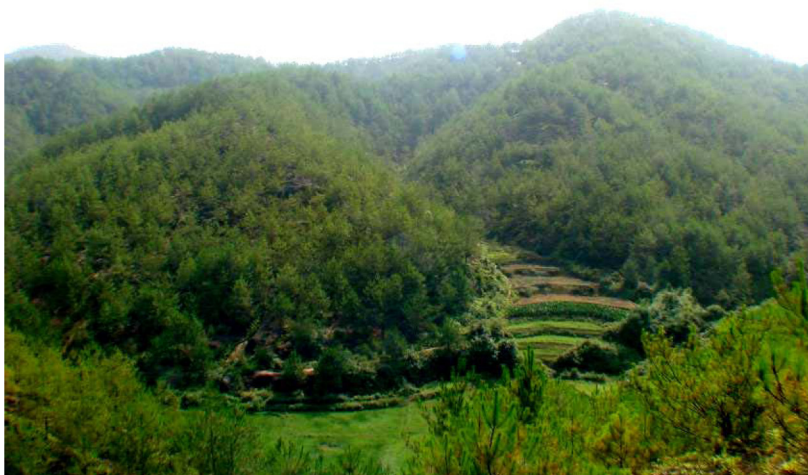
Fig. S1. Changes in the landscape during the soil and water conservation project in Changting County from 2000 (*Top*) to 2008 (*Bottom*).

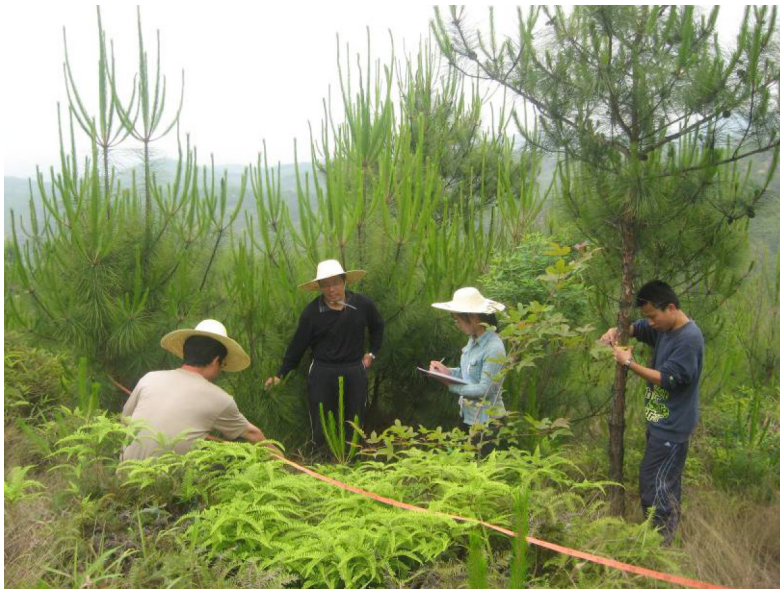
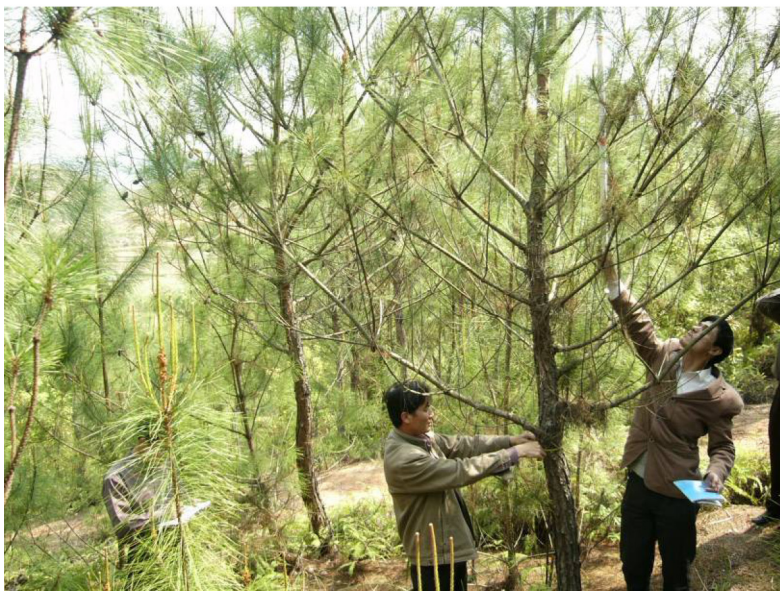
Fig. S6. (Top) Using a steel tape to measure vegetation cover. (Bottom) Measuring tree cover and collecting samples to describe species diversity in the study plots.

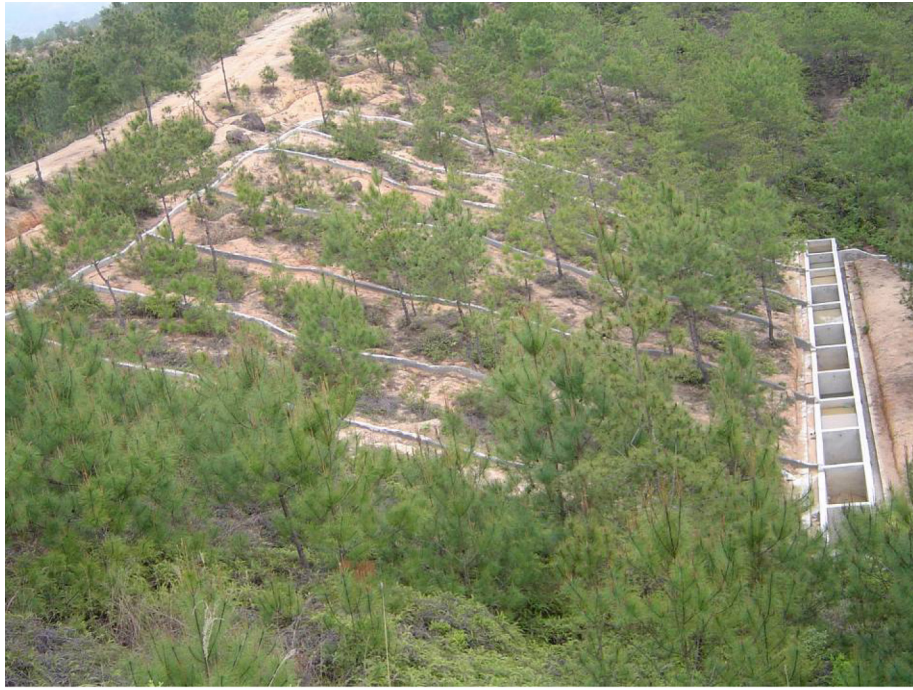
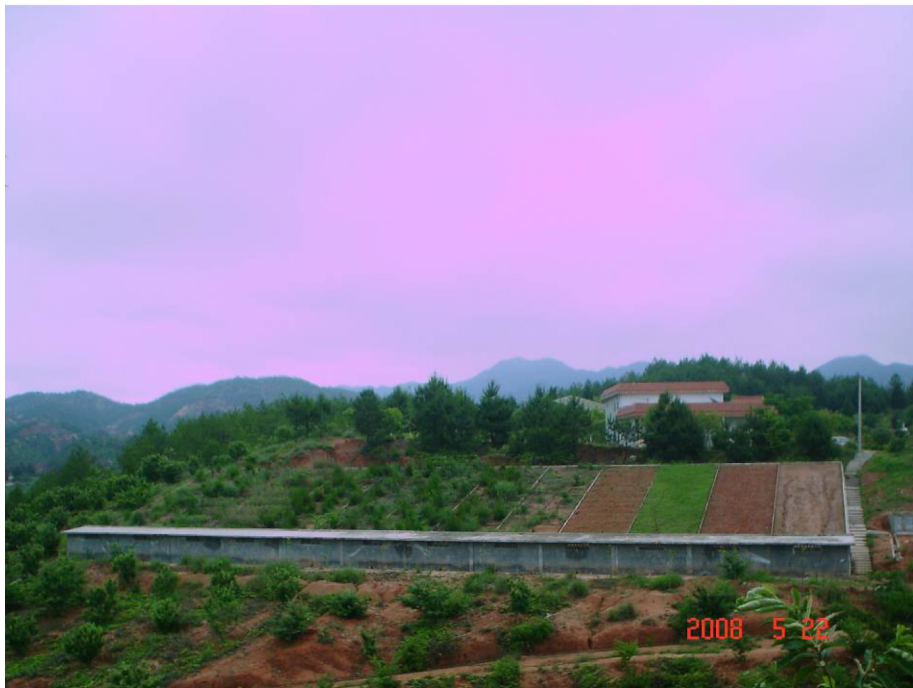
Fig. S7. To monitor run-off and soil erosion in Changting County, sedimentation ponds were constructed on representative slopes at each village (*Top*) and artificial sand sedimentation ponds (*Bottom*) were constructed at a monitoring station used for the soil and water conservation project.

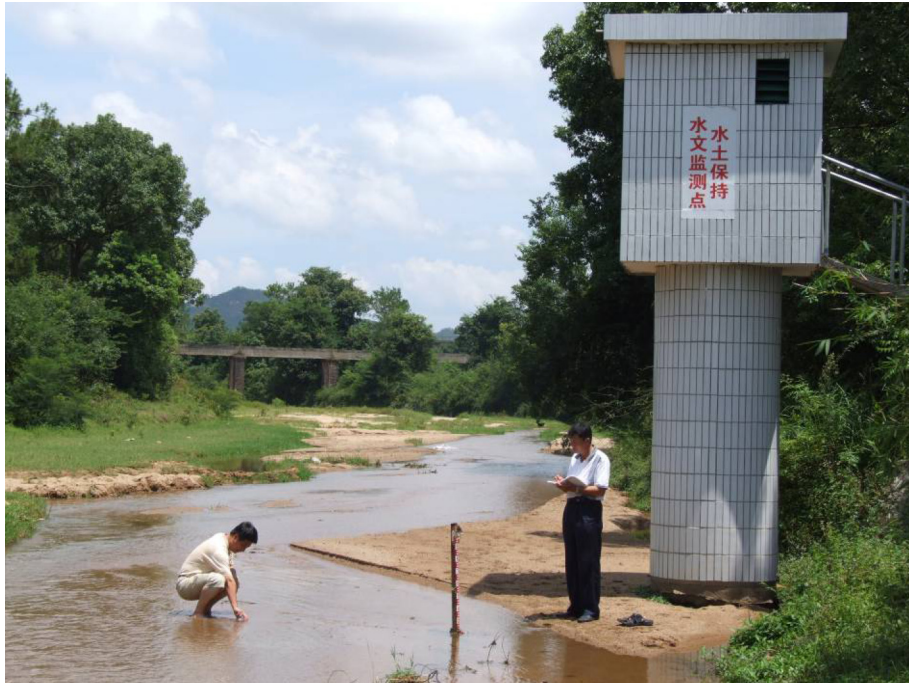
Fig. S8. The quantity of run-off and water samples to detect soil erosion were measured every 2 and 12 h, respectively, downstream of the project area.
